9241414 Kenworth/Peterbilt Condenser Product Note

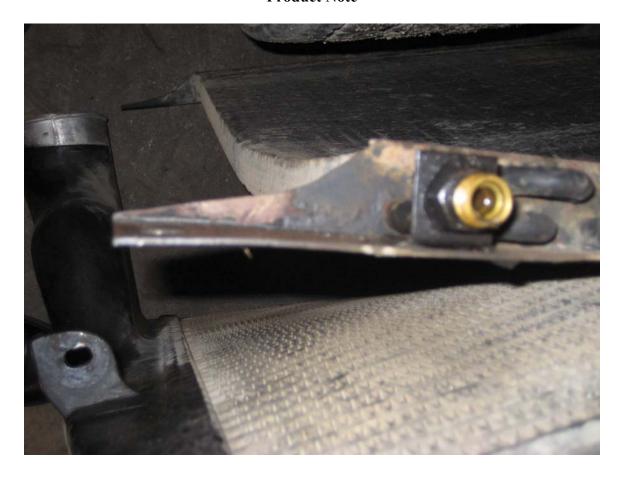
Check the condenser bottom bracket as compared to the unit removed from the truck. If the removed unit looks like the unit shown in the above illustration, proceed to check the truck for hood brace clearance with the hood closed and the old unit bolted in position. If required cut and notch the replacement bracket accordingly.
